Operation, Maintenance, and Surveillance (OMS) Manual

Giant Mine Remediation Project

Operation, Maintenance and Surveillance Manual (Version H)

WSP Canada Inc.

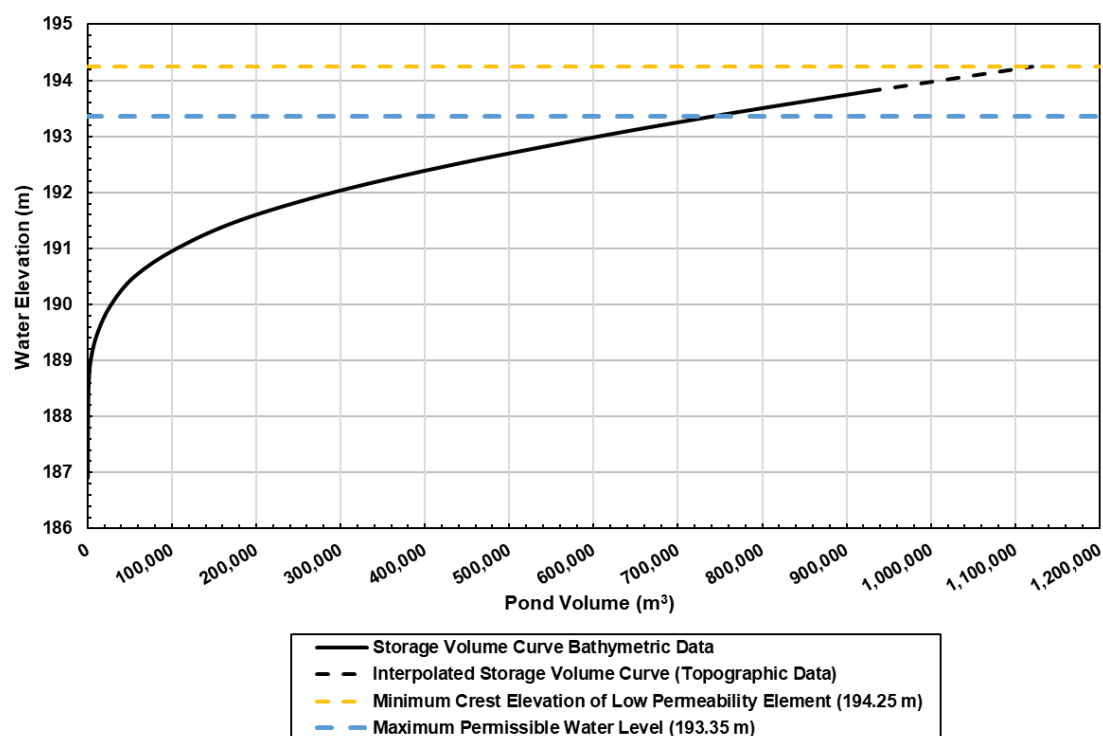
**Figure 7: Water Elevation Versus Storage Volume – Northwest Pond**

- The storage volume versus water elevation of the Northwest Pond is shown in Table 5 and Figure 7.
- The storage volume versus water elevation of the North Pond is shown in Table 6 and Figure 8.
- The storage volume versus water elevation of the Polishing Pond and Settling Pond is shown in Table 7 and Figure 9.

(2) Maximum permissible water level (minimum freeboard). Pond volume based on linear interpolation of 2019 bathymetry data.

(3) Minimum crest elevation of low permeability element at Dam 21B based on 2024 dam crest survey. Pond volume estimated based on linear extrapolation of staged storage curve in Golder (2020c).

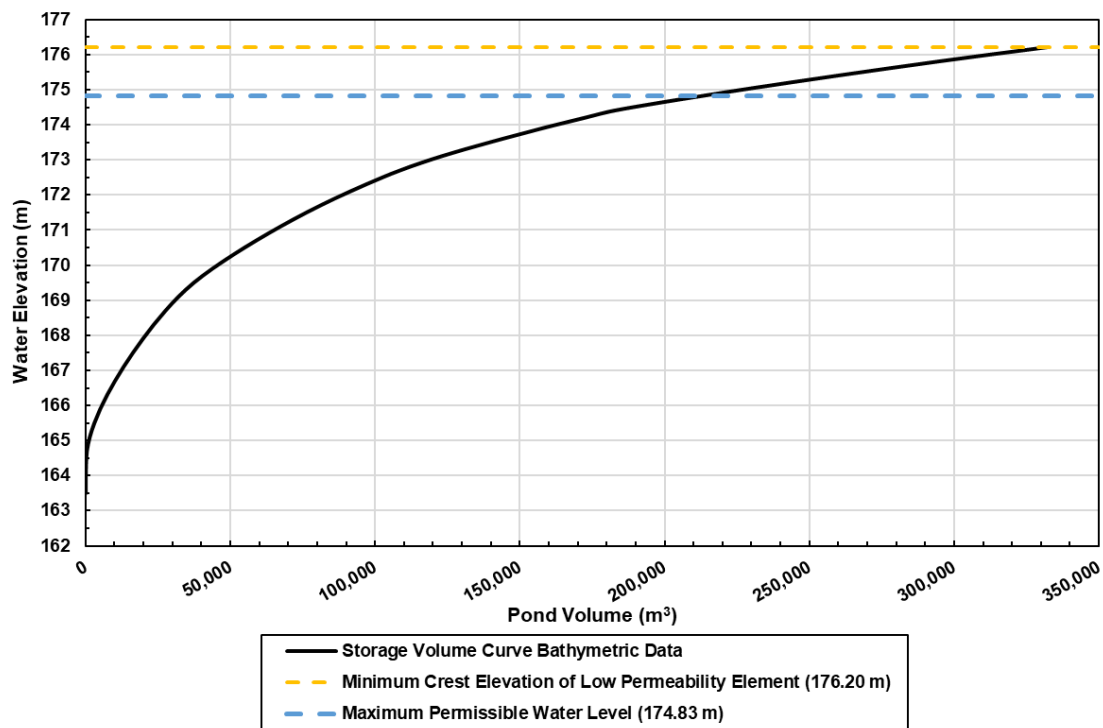
Figure 9: Water Elevation Versus Storage Volume – Polishing Pond and Settling Pond

(1) Maximum permissible water level (corresponding to minimum freeboard).

(2) Minimum crest elevation of low permeability element (e.g., spill point).

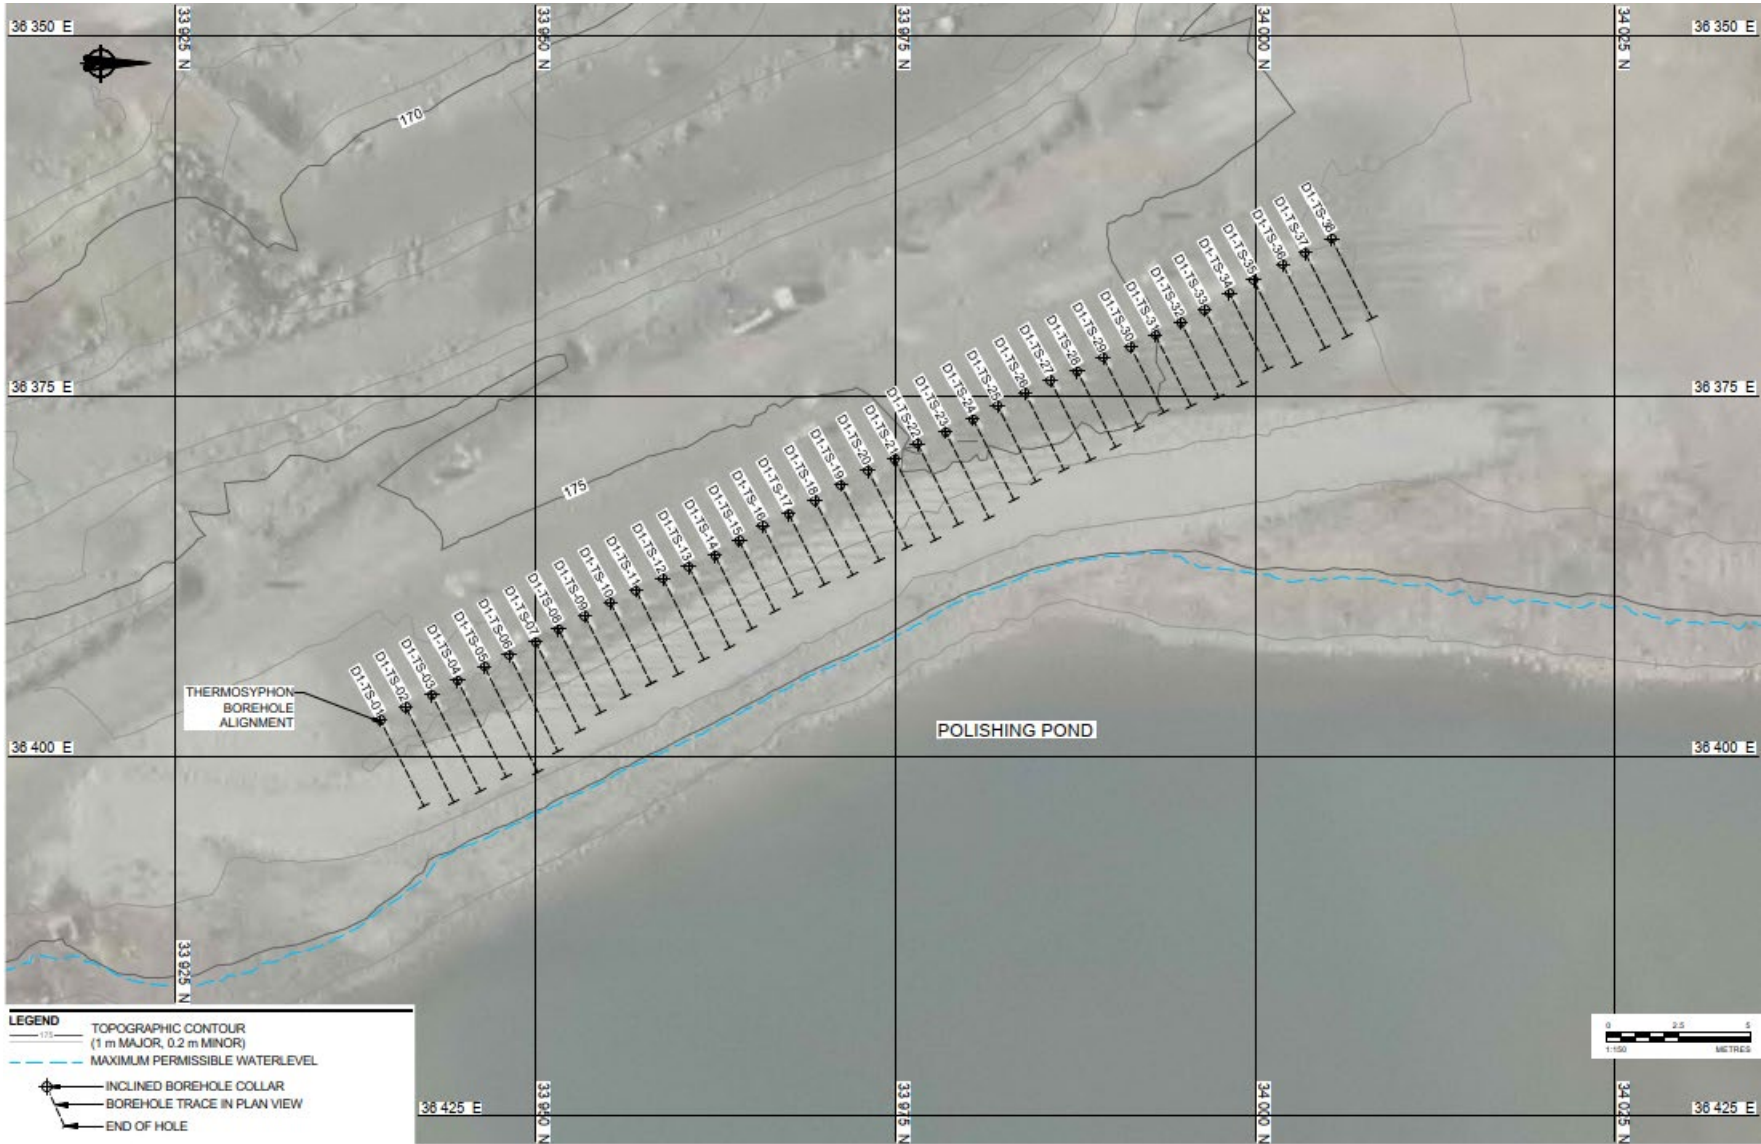
Figure 16: Dam 1 Thermosyphons Alignment

Thirty-eight inclined passive thermosyphons were installed in a row at Dam 1 during remediation works completed in 2020 (Golder 2021b). The location of the thermosyphon row is shown in Figure 16. The thermosyphons were installed to extract heat from the foundation of Dam 1 to induce freeze-back of the permafrost to limit the settlement of the dam.

The thermosyphons are to be visually inspected as part of the routine inspections of Dam 1. Inspections are to identify if thermosyphons appear damaged or require maintenance. If damage is observed, report it to the Mine Manager (Section 9.4.5 provides further maintenance instructions). Also, inspections should note if ponded water or accumulation of snow are observed near the thermosyphons as this may affect thermal performance.

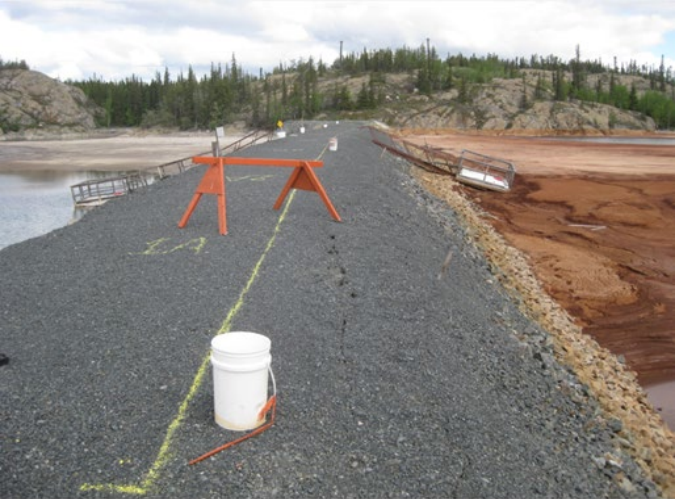
Longitudinal Cracks (Record Length, Width, and Depth)

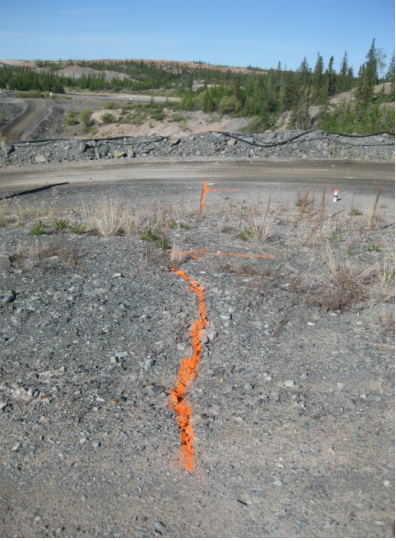
Transverse Cracks (Record Length, Width, and Depth)

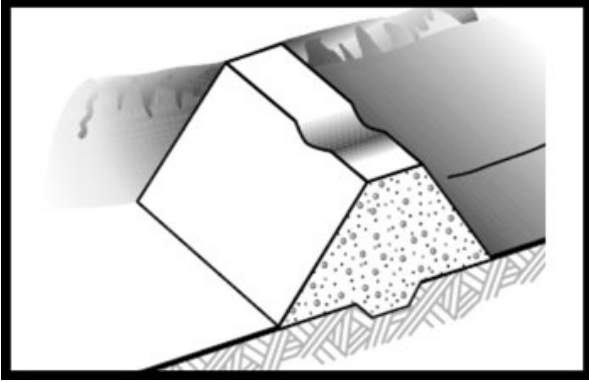
INSPECTION ITEM	EXAMPLE IMAGE
Settlement (Record Length, Width, and Depth)

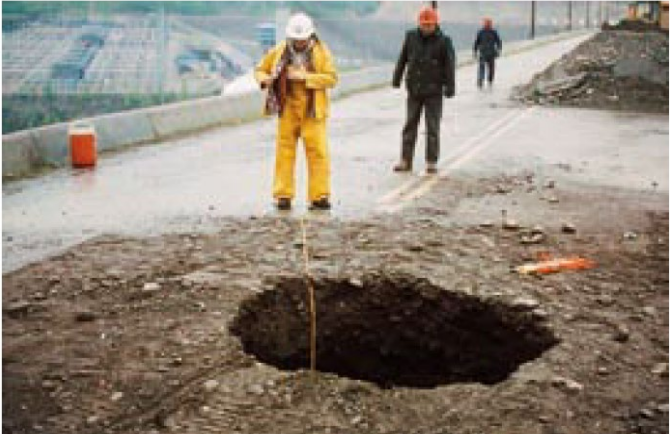
Sinkhole (Record Size and Depth)

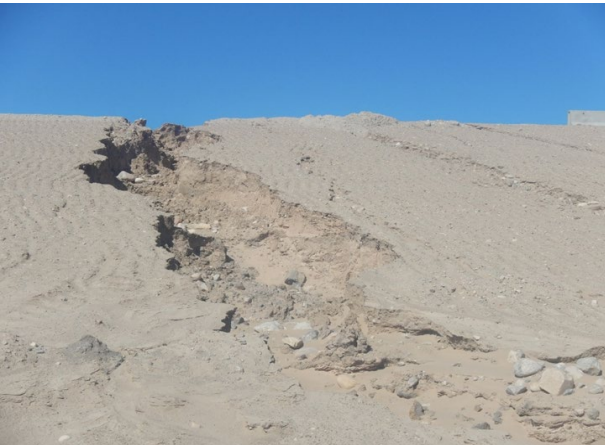
Sloughing/Erosion (Record Size and Depth)

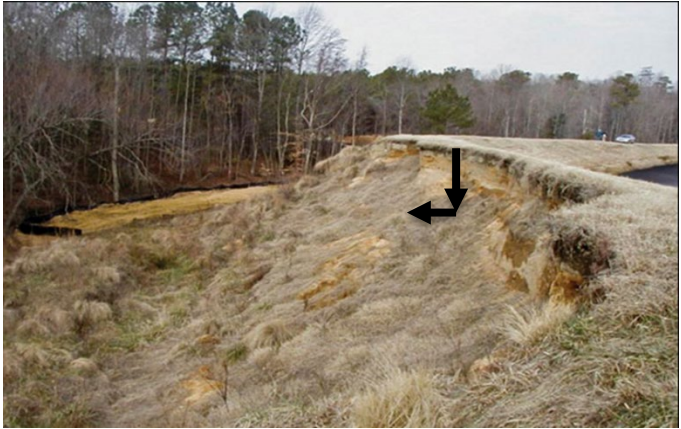
INSPECTION ITEM	EXAMPLE IMAGE
<p>Sliding (Record length of slip as well as vertical and lateral movement)</p>

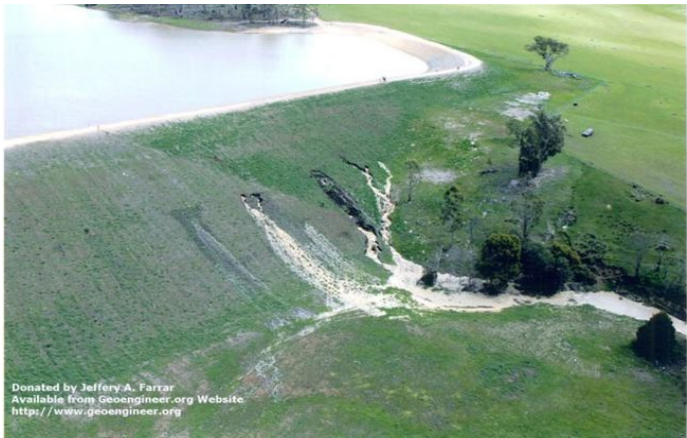
<p>Seepage / Wet Areas on Slopes (Estimate flow and note whether clear or dirty')</p>
