# Operation, Maintenance, and Surveillance (OMS) Manual

## *Giant Mine Remediation Project*

Operation, Maintenance and Surveillance Manual (Version G)

Reference No. 18102211-863-R-Rev0-45000D

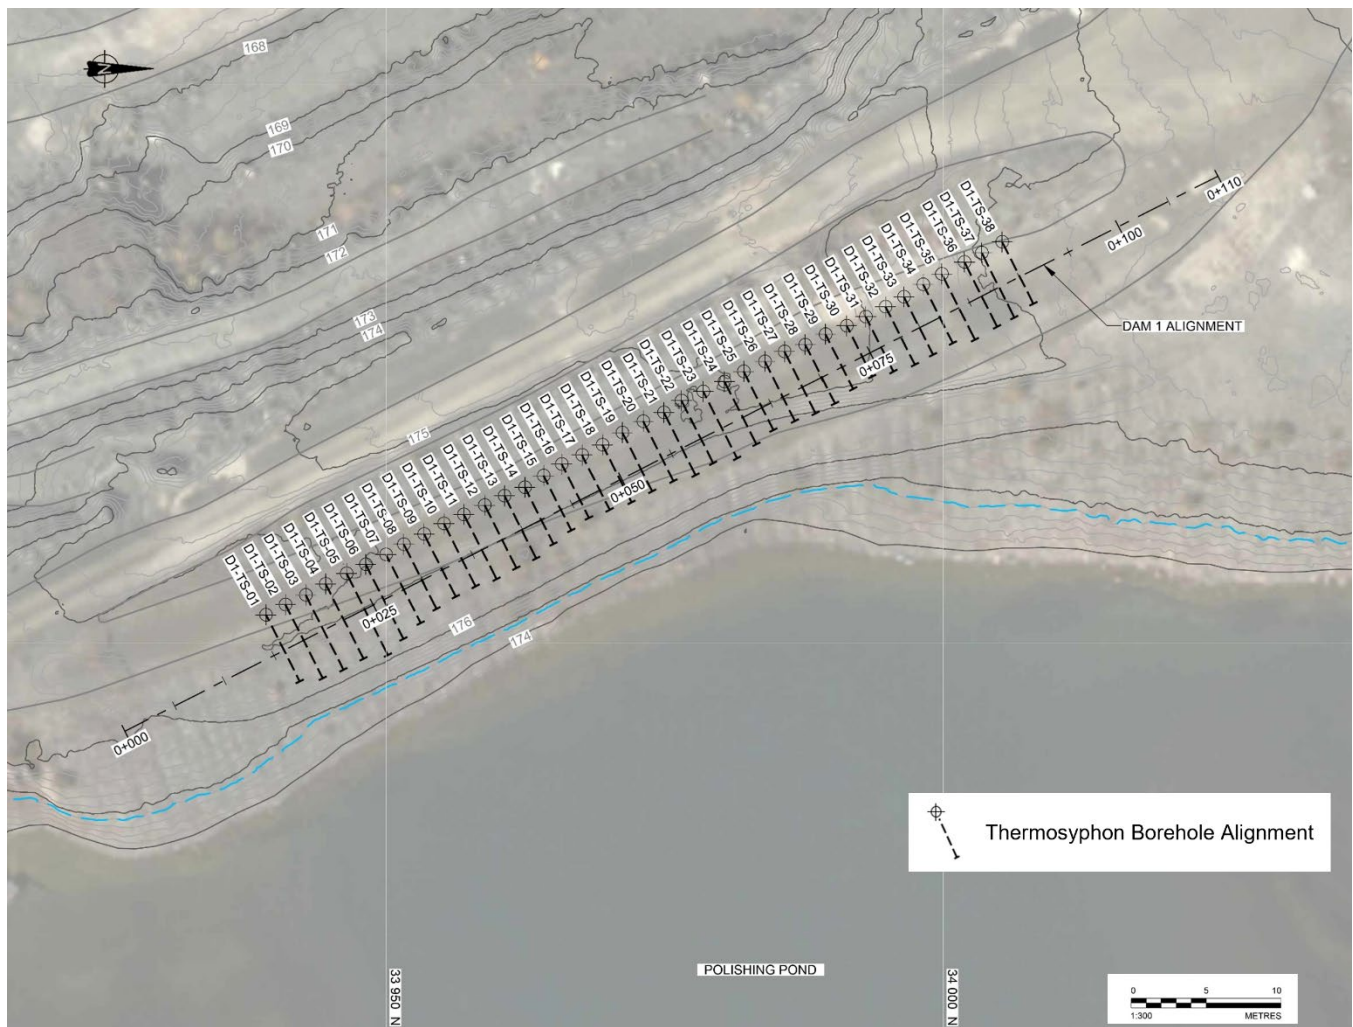
Figure 16: Dam 1 Thermosyphons Alignment

Thirty-eight inclined passive thermosyphons were installed in a row at Dam 1 during remediation works completed in 2020 (Golder 2021b). The location of the thermosyphon row is shown in Figure 16. The thermosyphons were installed to extract heat from the foundation of Dam 1 to induce freeze-back of the permafrost to limit the settlement of the dam.

The thermosyphons are to be visually inspected as part of the routine inspections of Dam 1. Inspections are to identify if thermosyphons appear damaged or require maintenance. If damage is observed, report it to the Mine Manager (Section 9.4.5 provides further maintenance instructions). Also, inspections should note if ponded water or accumulation of snow are observed near the thermosyphons as this may affect thermal performance.

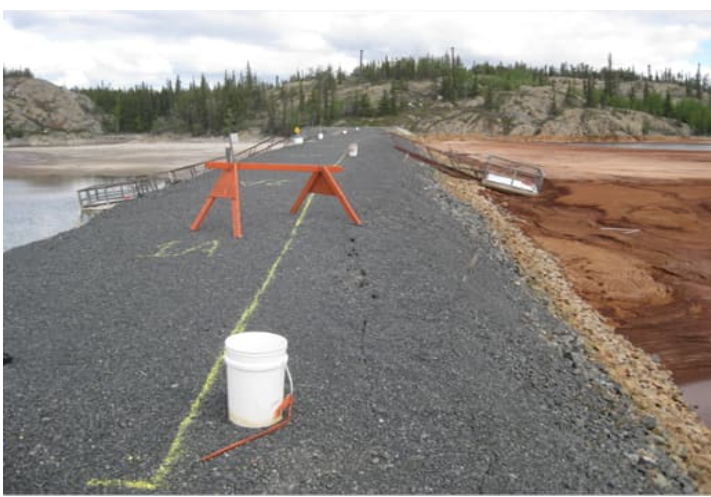
| INSPECTION ITEM | EXAMPLE IMAGE |
|---|---|
| Longitudinal Cracks<br>(Record Length, Width, and Depth) | |

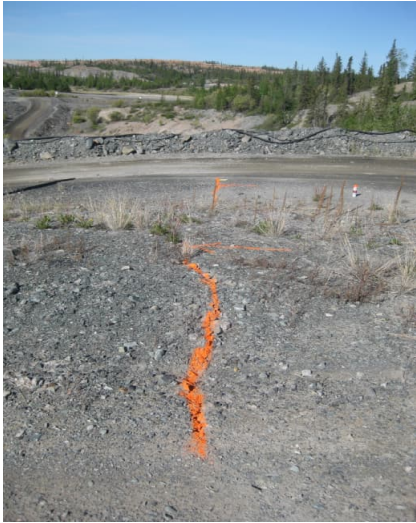
| INSPECTION ITEM | EXAMPLE IMAGE |
|---|---|
| Transverse Cracks<br>(Record Length, Width, and Depth) | |

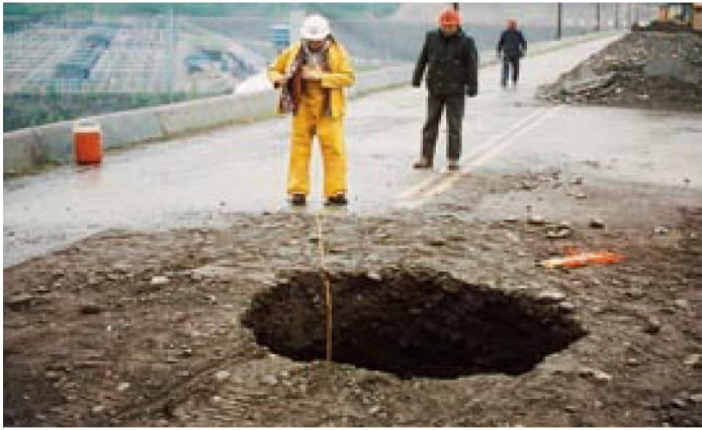
| INSPECTION ITEM | EXAMPLE IMAGE |
|---|---|
| Sinkhole<br>(Record Size and Depth) | |

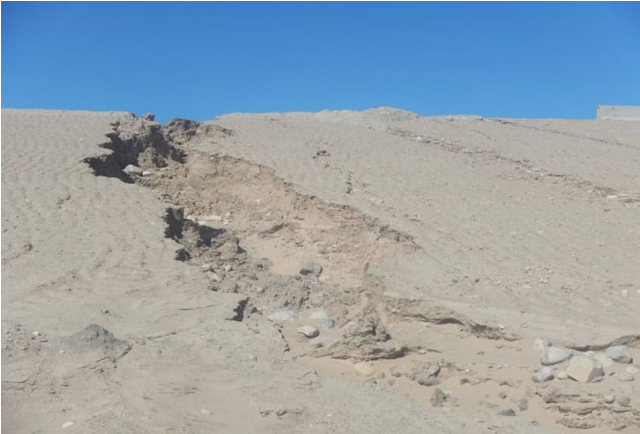
| INSPECTION ITEM | EXAMPLE IMAGE |
|---|---|
| Sloughing/Erosion<br>(Record Size and Depth) | |

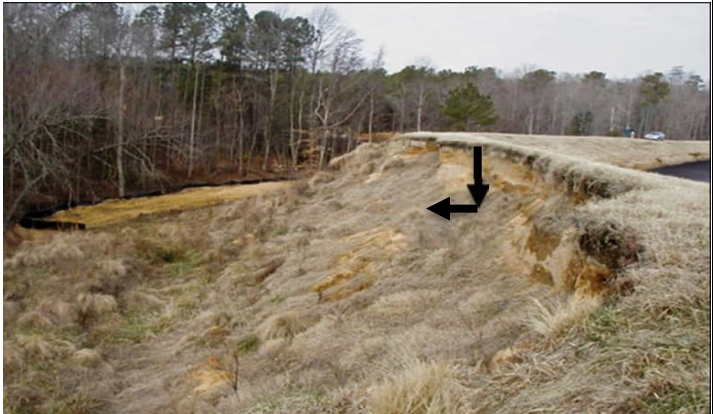
| INSPECTION ITEM | EXAMPLE IMAGE |
|---|---|
| <p>Sliding<br/>(Record length of slip as well as vertical and lateral movement)</p> | |

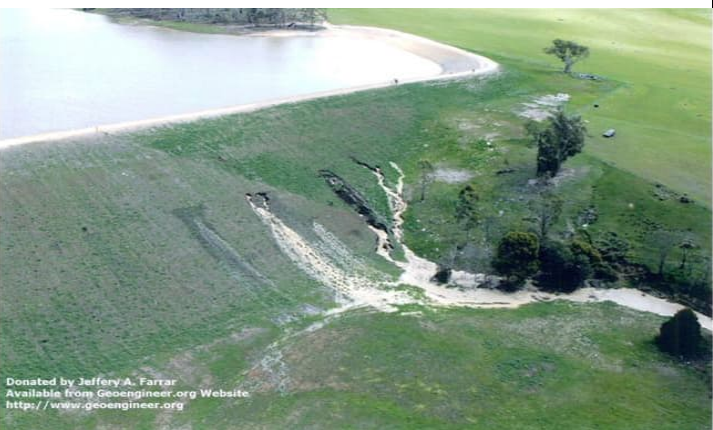
| INSPECTION ITEM | EXAMPLE IMAGE |
|---|---|
| <p>Seepage / Wet Areas on Slopes<br/>(Estimate flow and note whether clear or dirty')</p> | <p style="font-size: small;">Donated by Jeffery A. Farrar<br/>Available from Geosignpost.org Website<br/><a href="http://www.geosignpost.org">http://www.geosignpost.org</a></p> |

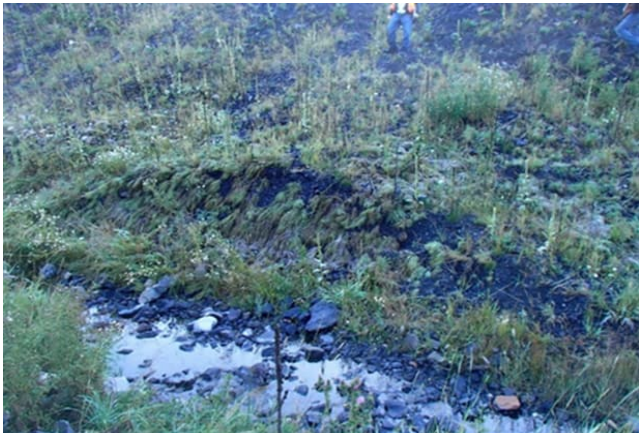
| INSPECTION ITEM | EXAMPLE IMAGE |
|---|---|
| <p>Seepage / Wet Areas at Toe<br/>(Estimate flow and note whether clear or dirty')</p> | |
